Service Bulletin 31

1. General	
(a) Service Bulletin No:	31
(b) Revision / Date	2 / January 2021
(c) Title:	Wear of Exposed Kevlar Control Cords
(d) Description:	Inspection of exposed Kevlar control cords when used in conjunction with metal rings
(e) Applicability:	EASA.BA.021 (Lindstrand, T&C, and Sky Balloons) All envelopes fitted with exposed Kevlar cord.
(f) Effectivity:	All applicable CN's on TC listed above. Except for Thunder & Colt envelopes CN3000 or later.

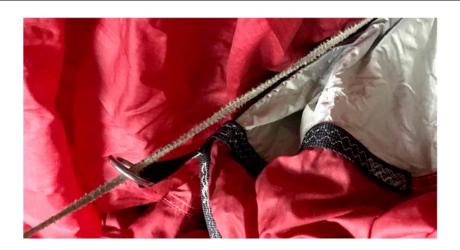
A recent incident involving a Sky Balloons hopper envelope has been reported where the upper control line has failed after being significantly worn in service. The use of exposed Kevlar control cord (a Kevlar cord without a protective sheath) in conjunction with metal rings can cause significant wear when compared to sheathed lines used with pulleys.

Inspect exposed Kevlar cord for wear on section that passes through metal rings in the envelope. Below shows a photo of the failed control cord near to its failure location:

If the length of control cord that passes through the metal ring is significantly worn compared to parts of the control cord that do not pass through the ring, the control cord must be replaced.

If replacement is deemed necessary, the rip line should be replaced using any of the following materials:

CE-4135-0001 - 3.5mm Black Sheathed Kevlar Core

CE-4135-0002 - 3.5mm Green Sheathed Kevlar Core

CE-4135-0003 - 3.5mm Red Sheathed Kevlar Core
