LINDSTRAND HOT AIR BALLOONS LTD

SERVICE BULLETIN NO. 12

ISSUE 2 – DATED 10-05-2012

TITLE: Female ACME Thread Hose Connectors (Rego type)

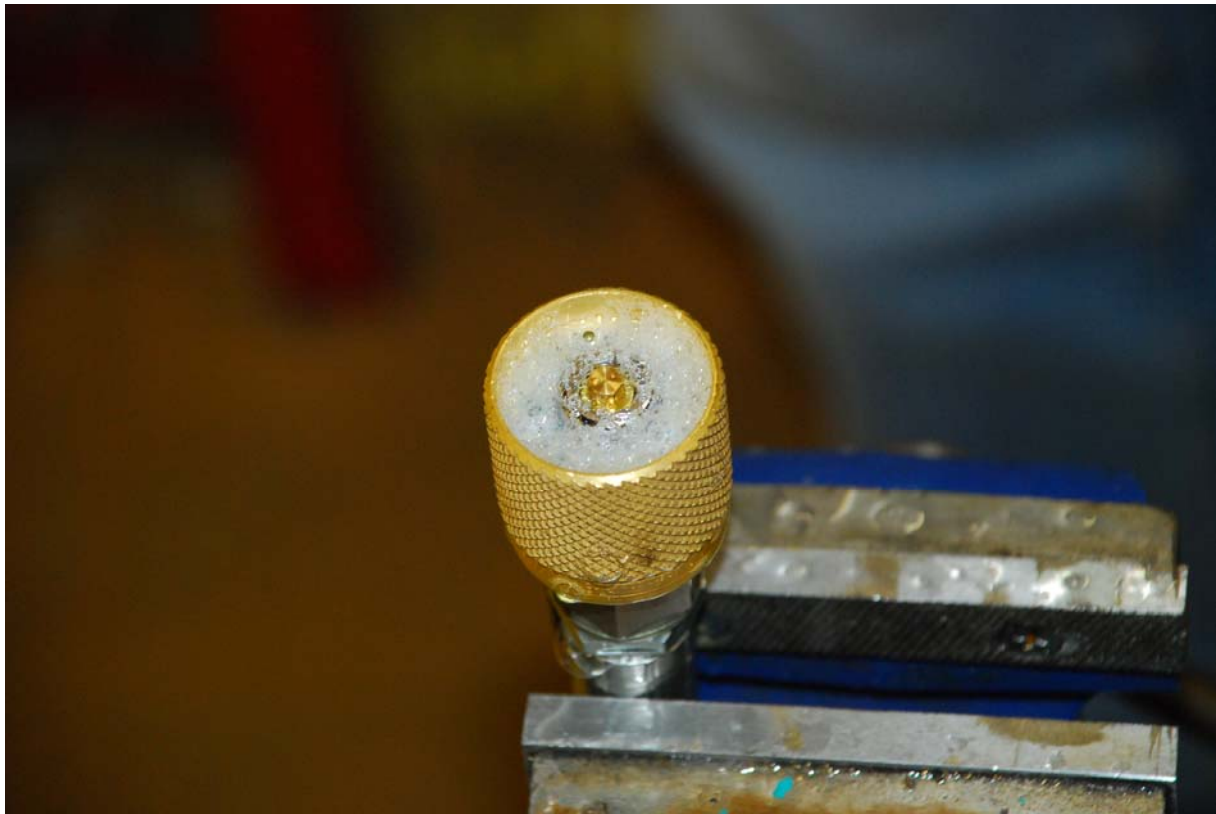
Background: We have had three reported incidents of the female ACME threaded connectors (Rego type) leaking when connected to the cylinder with the cylinder valve turned on. Investigation into the cause of these failures has revealed the possibility that other similar connectors produced between the dates given above may not have been assembled with sufficient tightness.

Connect the fuel hose to a supply of propane and open the cylinder valve so that the hose is pressurised. If compressed air is available this may be used as well. Disconnect the Female ACME coupling from the cylinder so that the pressure is retained in the hose. Pour leak detector fluid or water with washing up liquid into the female connector and observe for leaks for 1 minute (see photo 1)

Photo 1 Coupling showing a leak.

If a leak is detected then follow this procedure to tighten the threaded connection.

Tools required are a 22mm open ended spanner (wrench) A 13/16" long socket with an outside diameter of not greater than 27mm (1 and 1/16"), a suitable sized ratchet drive. Hold the back nut with the spanner (wrench) and use the ratchet and long socket to tighten the internal Spigot onto the back nut. (See Photo 2 for identification of parts) The indicative torque required is 30 -34 Nm (22-25lbf ft)

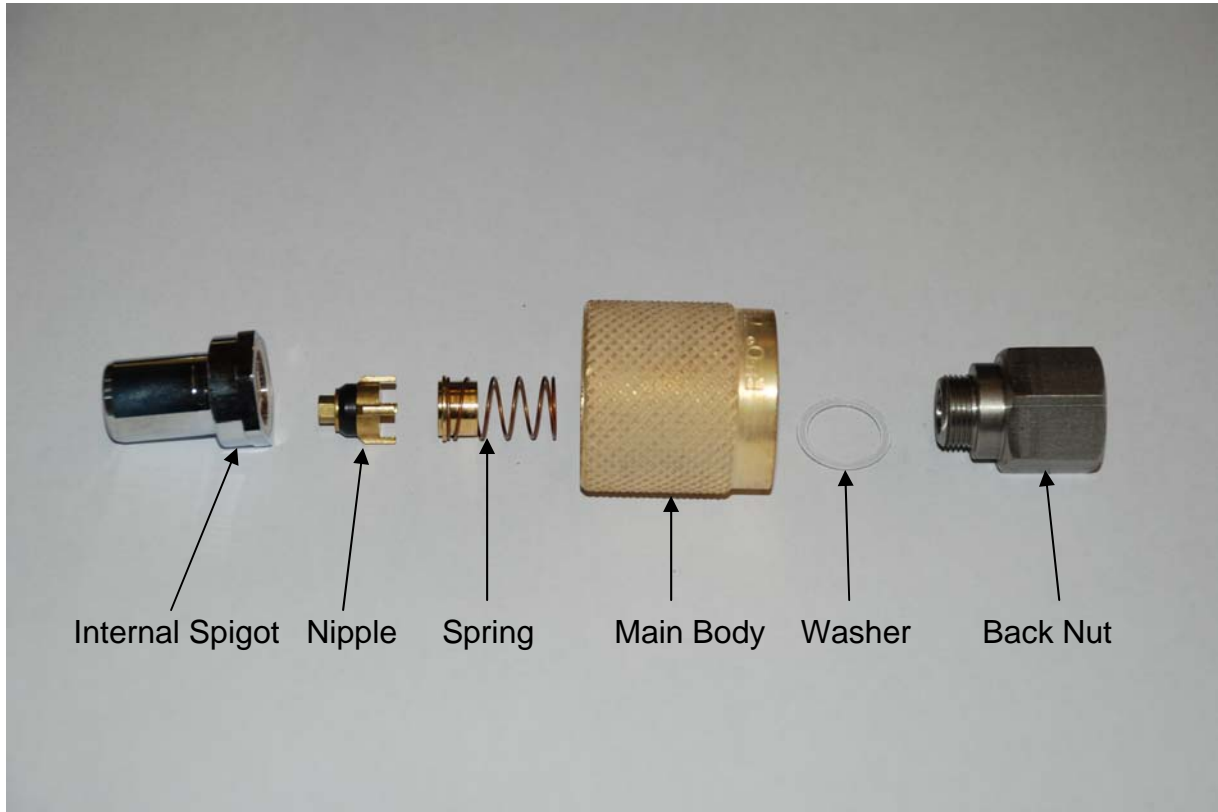
Photo 2 Coupling Components

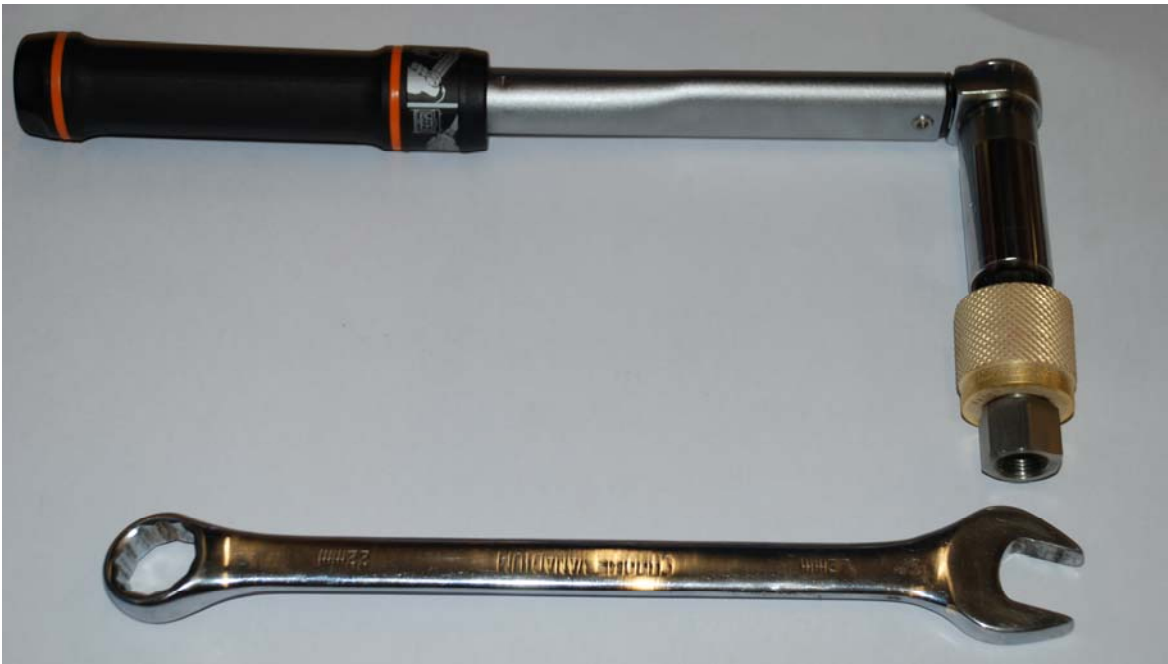
Photo 3 Tightening the coupling

Retest the integrity of the coupling by repeating the leak test described above. If a leak is still detected then contact the factory for a replacement connector.
