LINDSTRAND HOT AIR BALLOONS LTD

SERVICE INSTRUCTION NO. 5

Issue 1, Dated 3 August 2011

Title: 3 panel rotation vents inspection advice
Classification: Advisory
Applicability: Lindstrand A and C type envelopes 105 and larger
Compliance Standard: Achieve During Next annual / 100 hour Inspection.

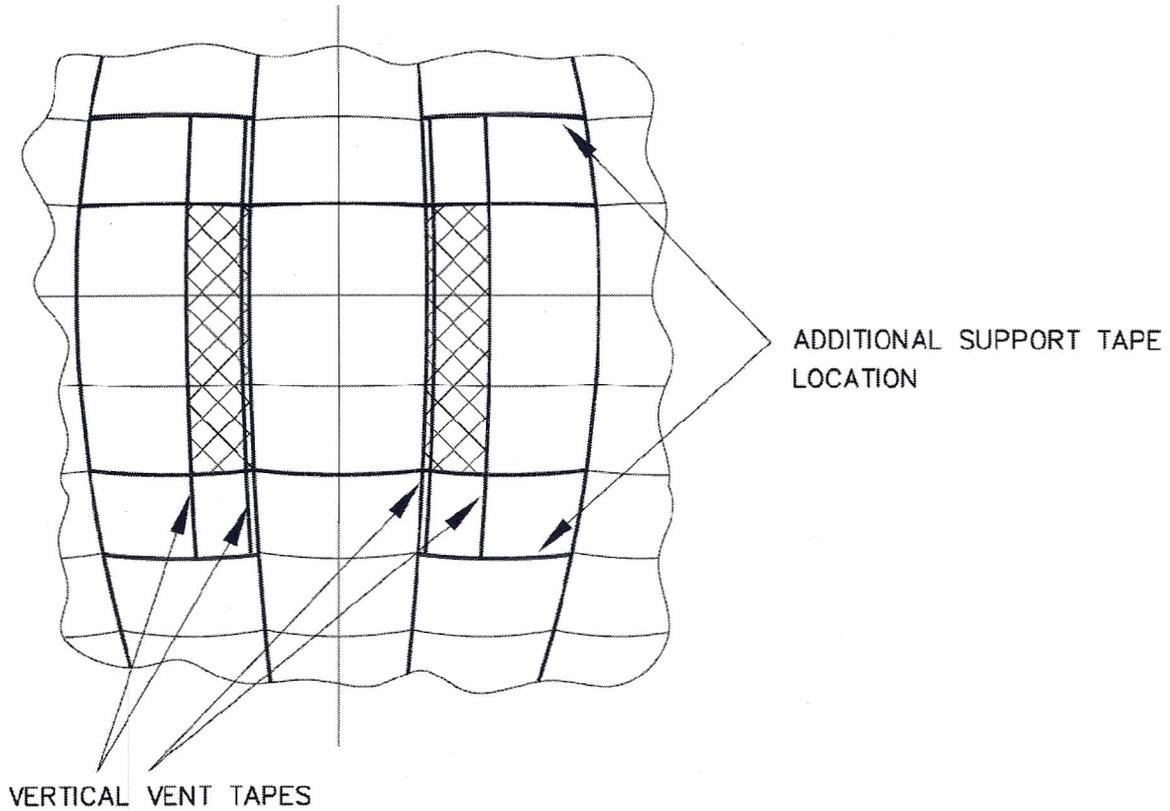
Figure 1

During our continuous monitoring of the performance of our balloons we have noted a number of examples of the external turn vent flap load tapes causing excessive stress in the panel above where it terminates, in envelopes over 400hours or more.

Inspect the fabric in the panel above the turn vents especially close to the end of the load tape which is positioned on the outer edge of the external vent flap. Look for signs of fabric stress and or pulling apart of the fabric

If stress or damage is detected it is recommended that a strengthening tape is sewn across the horizontal seam. So that it extends between the two vertical tapes

The tensile strength of the tape should be 1040kg or greater (medium weight tape).

The sewing method is the standard method described in our maintenance manual.
