CAMERON BALLOONS LTD

SERVICE BULLETIN: SB11

Subject: **A-type Envelopes**

Title: **Inspection of 'Lens' panel to 'Top' panel seam.**

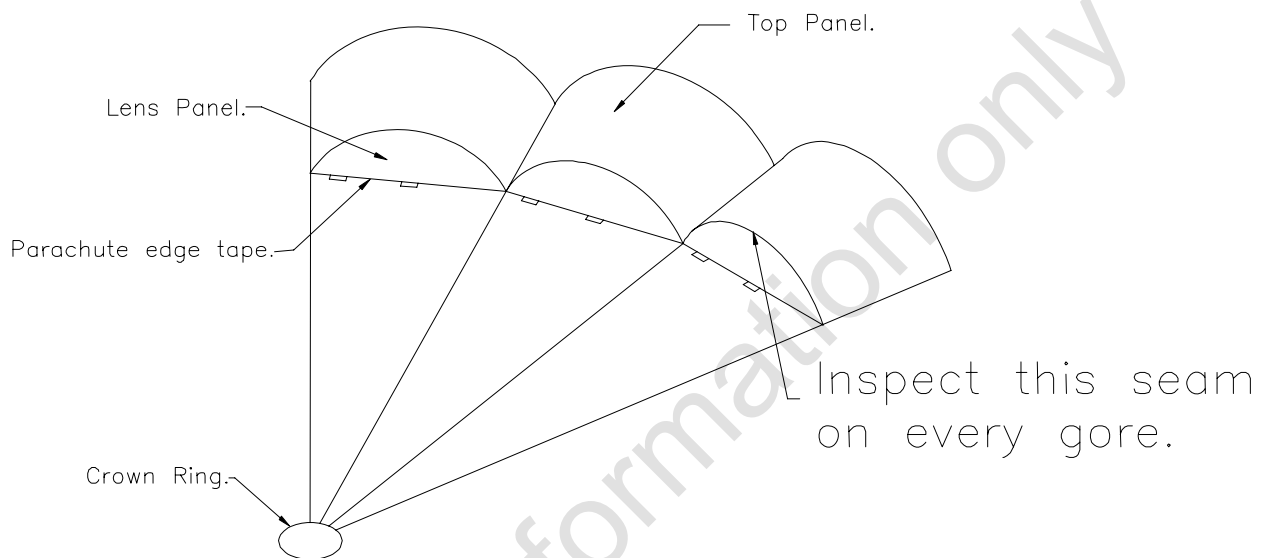
Reason for Modification: **Possible unpicking of envelope seam through contact with Parachute Velcro tabs.**

Unpack the balloon and locate the Crown Ring. Then carefully inspect the inside and outside of the seam indicated below for signs of unpicking.

2. If less than 2" (50mm) of damaged stitching is evident, this is acceptable until the next scheduled inspection, when any damaged stitching must be repaired in accordance with Section B of this Service Bulletin.
3. The seam must be repaired before further flight if any of the following apply
 - a) Both rows of stitching completely broken.
 - b) More than 2" (50mm) of either row of stitching completely broken.
 - c) Two or more sections of damage between vertical load tapes, where each section has less than 2" (50mm) of either row of stitching completely broken.
