Alert Service Bulletin 36

(a) No.:	36
(b) Revision / Date	1 / 2 nd April 2025
(c) Title:	PRV Adaptor CB8426 for Legacy Cylinders
(d) Description:	Inspection and possible replacement of adaptors in service based on pass criteria.

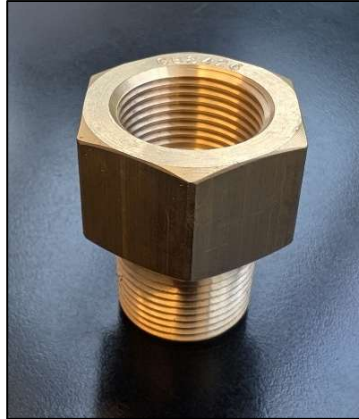
Figure 1 - New CB8426, PRV Adaptor

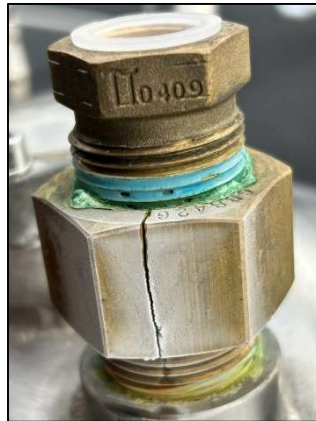
Three instances of failed CB8426 adaptors have been reported in the last 9 months. Failed components have presented with a crack located on the upper hex portion of the adaptor.

Figure 2 - Cracked CB8426, PRV Adaptor

Affected PRV adaptors installed in cylinders must be visually inspected for cracks within 24 hours of receipt of this bulletin. Any cylinders found to have cracked adaptors installed should be emptied of fuel immediately. Contact Cameron Balloons in the event of the discovery of a crack failure.

PRV adaptors found without cracks can continue to be used for flight but must be inspected before each flight.
